T-75 Moore Farmhouse nr. Queen Anne site private

## INVENTORY FORM FOR STATE HISTORIC SITES SURVEY

James F. Moore House

T-75

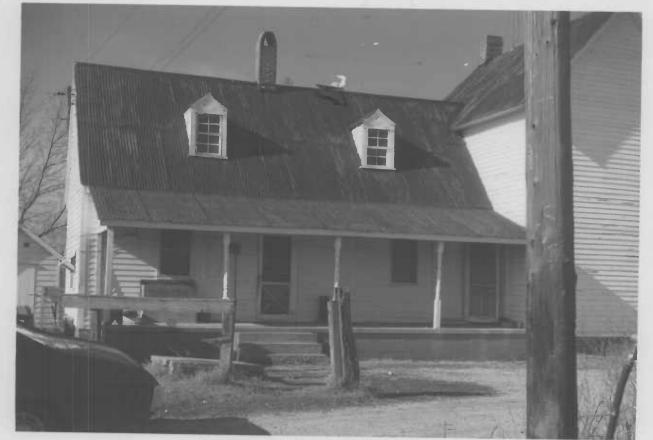
As it stood in 1970, it was composed of two rooms on both floors with a single window and door to each room on the east side. Two dormers pierced the roof as did a central chimney. Typical of the early 19th century, especially noticeable in Caroline County, was the fact that the 4/4 sash in the dormers were set horizontally.

12/70 MiBourne East facade
